# Exterior Restoration of the Country Club Christian Church

Kansas City, MO

Submitted by Concrete & Masonry Restoration Company, Inc.

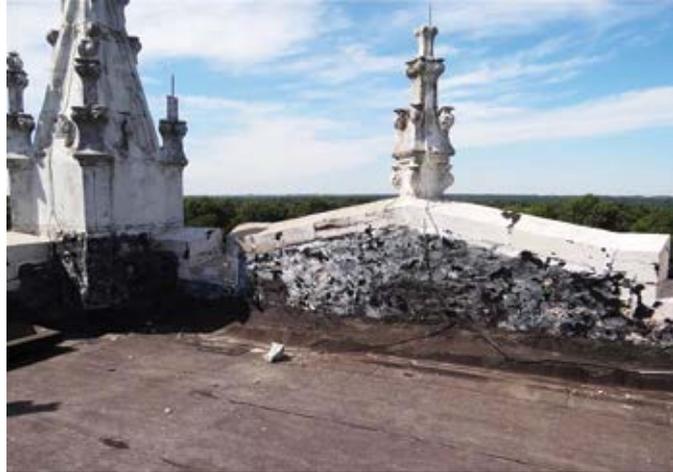
*Advanced deterioration of cast stone elements was prevalent*

Carbonation of the old cast stone was full depth, but was irrelevant to the deterioration of those units. The predominant mechanism of failure was freezing-and-thawing degradation. Severe deterioration of cast stone units was also caused by a non-breathable coating application in 1987. Other factors contributing to deterioration of cast and cut stone had resulted from localized areas of

The selected repair program included removal and reconstruction of large cast stone pinnacle structures at the base of the tower, around the perimeter of the sanctuary and the north wing, with new cast stone. Repair and maintenance of cut stone included repointing of deteriorated mortar joints and removal and replacement of cracked and deteriorated cut stone with units to match the existing stonework. Several hundred cut stones were removed and replaced.

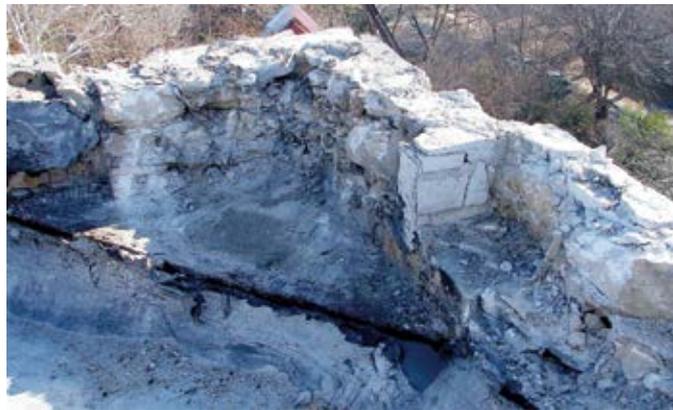
*Severely deteriorated stone and mortar presented safety concerns*

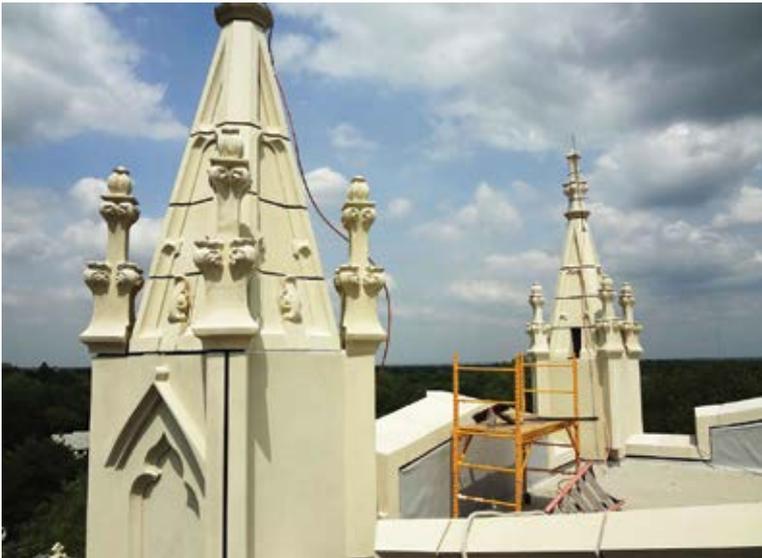
*Reconstruction of cast stone pinnacle structures*

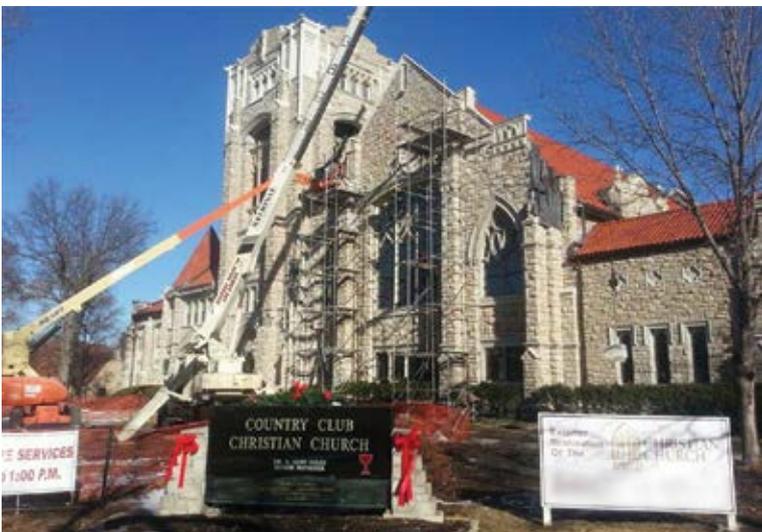
*Scaffolding, lifts, and a crane were used on the project*

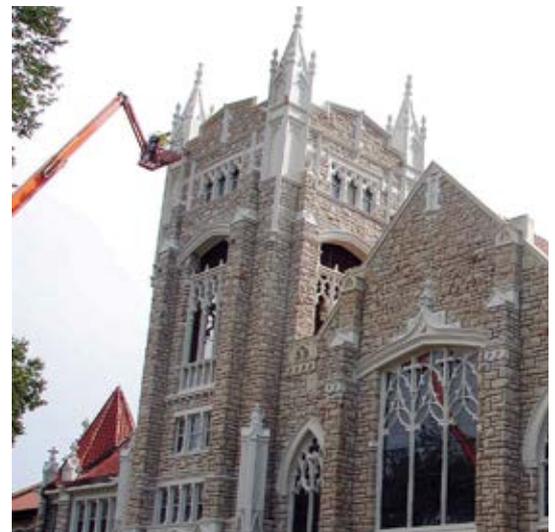
*Telescoping lift used to access repair areas*

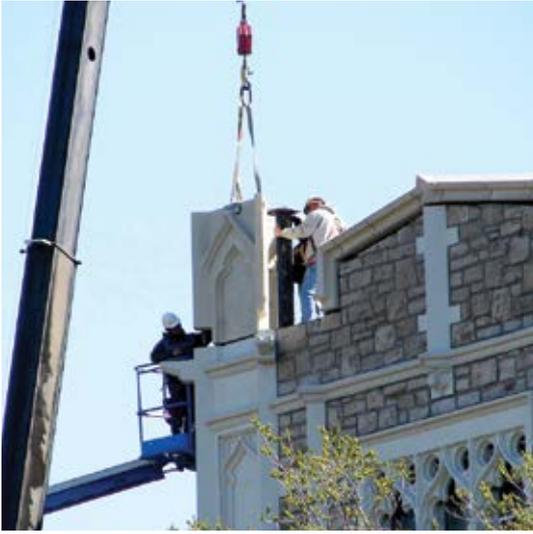
*New cast stone pieces were received on site and hoisted into place*

As the new cast stone pieces were received on site, parapet walls and cavities were rebuilt and flashed to receive the new units and assemblies. All new units and assemblies were inspected, compared

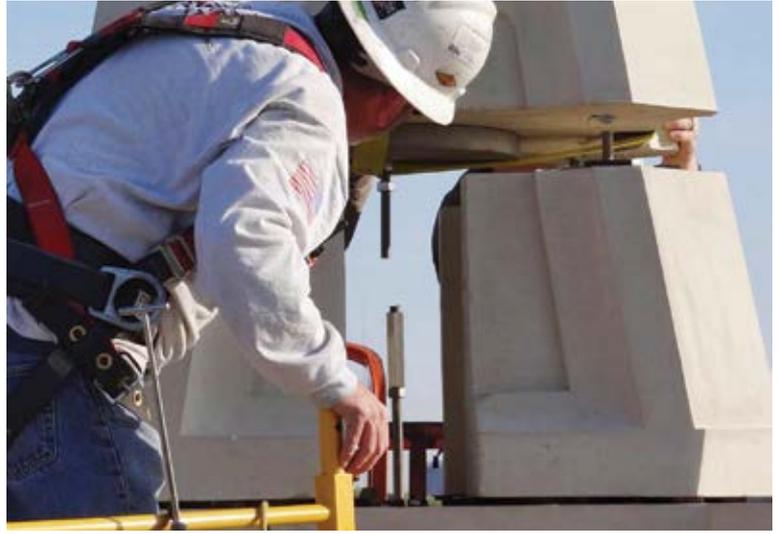
*Final assembly of some of the cast stone pieces*

to the shop drawings, and pre-constructed on the ground to be certain they would fit in position during final assembly.

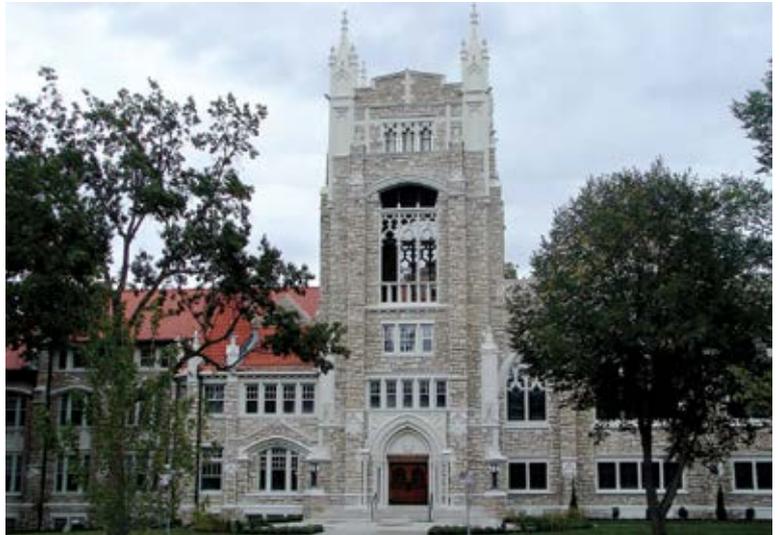
*Completed exterior restoration project*
