Culver Line Viaduct Rehabilitation

Brooklyn, NY

Submitted by Sika Corporation

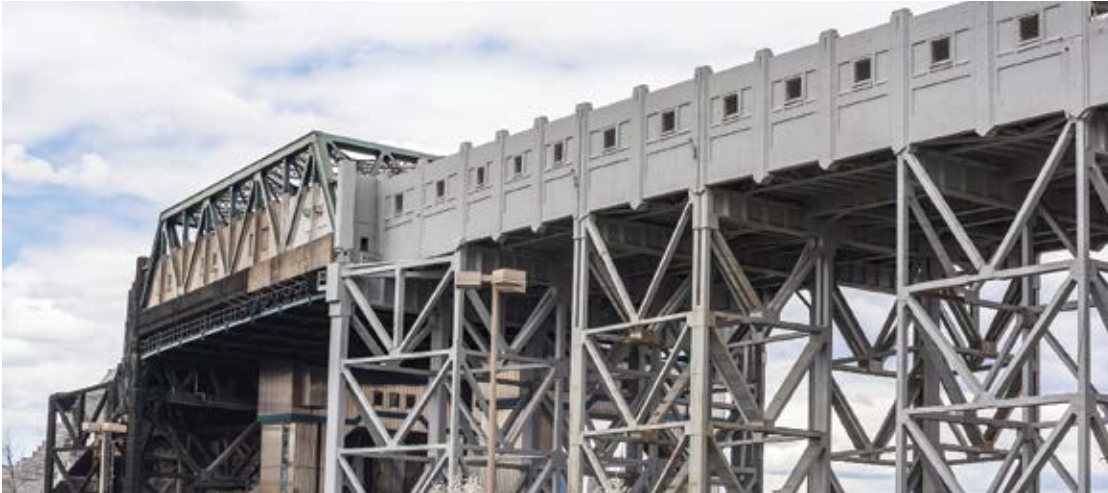
Culver Line Viaduct after concrete repairs

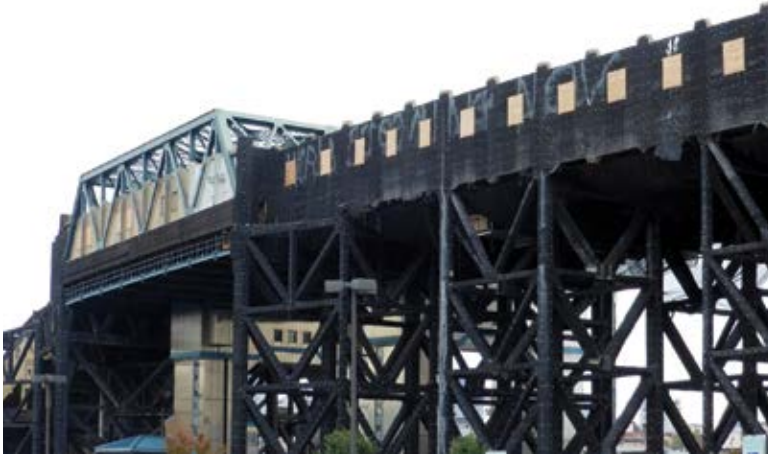
After many years of service, the Culver Line Viaduct was showing its age. Because there was no existing waterproofing membrane, water infiltration was a serious problem. As the water penetrated the concrete, it caused significant corrosion damage to the reinforcing steel and the underlying steel members encased in concrete. This led to cracking, spalling, and, ultimately, pieces of concrete coming loose from the structure. To protect the public from falling debris, in 2003, as a stopgap measure, the

Culver Line Viaduct prior to concrete repairs
