QUALITY ASSURANCE AND COMMISSIONING PROCESS IN HIGH ENVIRONMENTAL PERFORMANCE (HEP) HOUSE IN NY STATE

Terry Brennan, Mark Bomberg, Hugh Henderson, and Kevin Stack¹

ABSTRACT

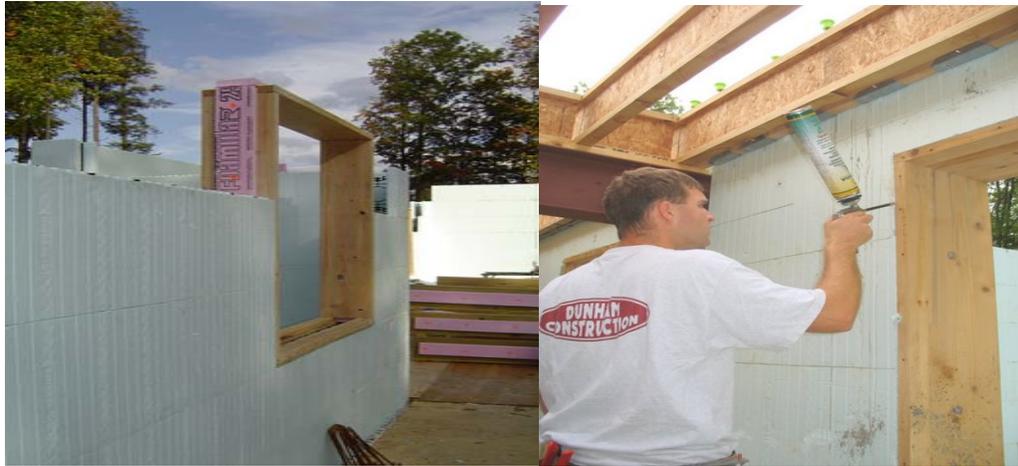
Figure 3 (a) Thermal insulation strip (extruded polystyrene) placed between the rough opening of the window and the concrete fill (left side). (b) Sealant foam application between the rough opening and the ICF blocks (right side).

The thermal insulation strip (see Figure 3a) cuts the short circuit between the rough opening and the concrete fill in the ICF and reduces the thermal bridging around the window frame. Caulking applied to the rough opening (see Figure 3b) reduces possible infiltration of air between the ICF and rough opening.

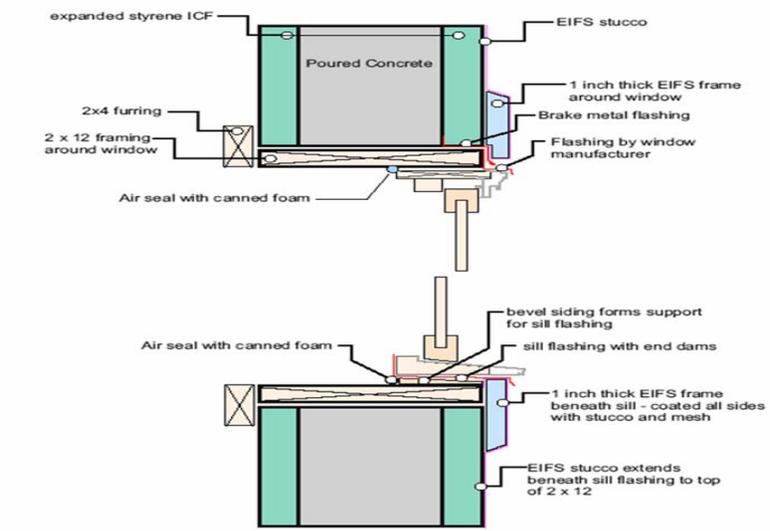
Figure 4 Schematic design of a window-wall interface

Figure 4 shows a schematic design of a wall-window interface. Flexible flashing with end dams was selected. It was drawn on the an additional EIFS window frame, which in turn provided an additional protection for air leakage that might occur under the rough opening. A sealant foam was used on the other side of the rough opening i.e., between the window frame and the rough opening.

After performing air tightness measurements additional air tightening of the wall/window took place. As shown in Figure 4, a peel and stick flashing strip covers the whole surface under the window frame. Yet, after mounting of the window on the positioning shims and fastening it to the rough opening the gap is filled with sealant foam. The inner surface of the foam is cut flush and finished with a corner bead of wet caulk. Then, an additional wood strip, also placed on the sealant foam is added on the inside surface of the window trim. This strip, provides an additional air tightness measure should the foam develop cracks during long-term performance.

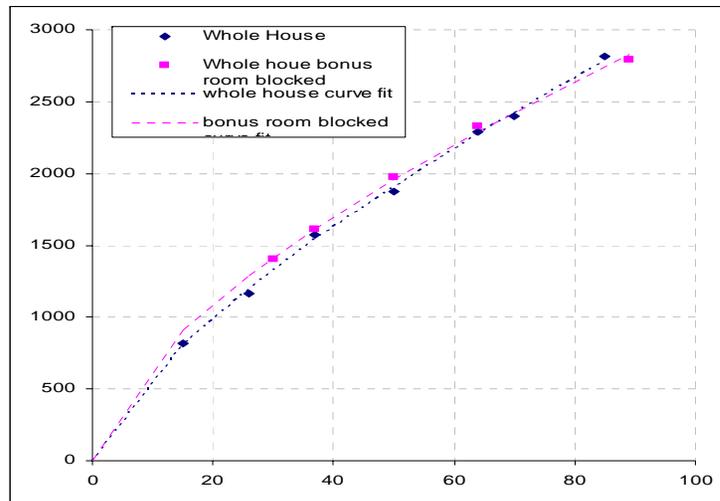
Three different series of pressure testing were performed during the construction. Figure 9 shows the results of depressurizing the house with the door to the bonus room over the garage open and with the door to the bonus room sealed and taped with polyethylene

Figure 9 Measured Q [cfm] vs DP [Pa] curves for whole house tests

Note: Curve fit In the first series of tests was poor and a leakage path through unsealed penetration for a few electrical cables was found. After the sealing of this connection results became more consistent as shown in Figure 9.

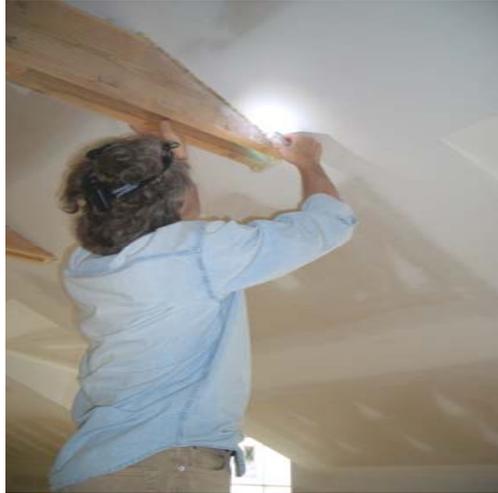
With the room pressurized to around 48 Pascal relative to outside a smoke bottle was used to test joints and penetrations for air leakage (see Figure 10). The windows themselves were quite airtight, with no leakage at the operating hardware or weather stripped sash. Air leaked behind the gypsum board at every penetration. The pressure drop over the gypsum board was around 1.7 Pascal, indicating that the foamed roof, wall and floor assemblies provide the air barrier. No effort was made to air-seal the gypsum board to the framing, window jambs or electric outlets so it is not a surprise that it is not the primary air barrier.

Figure 10 Search for the leaks from pressurized room with the smoke bottle and light to observe the smoke path.

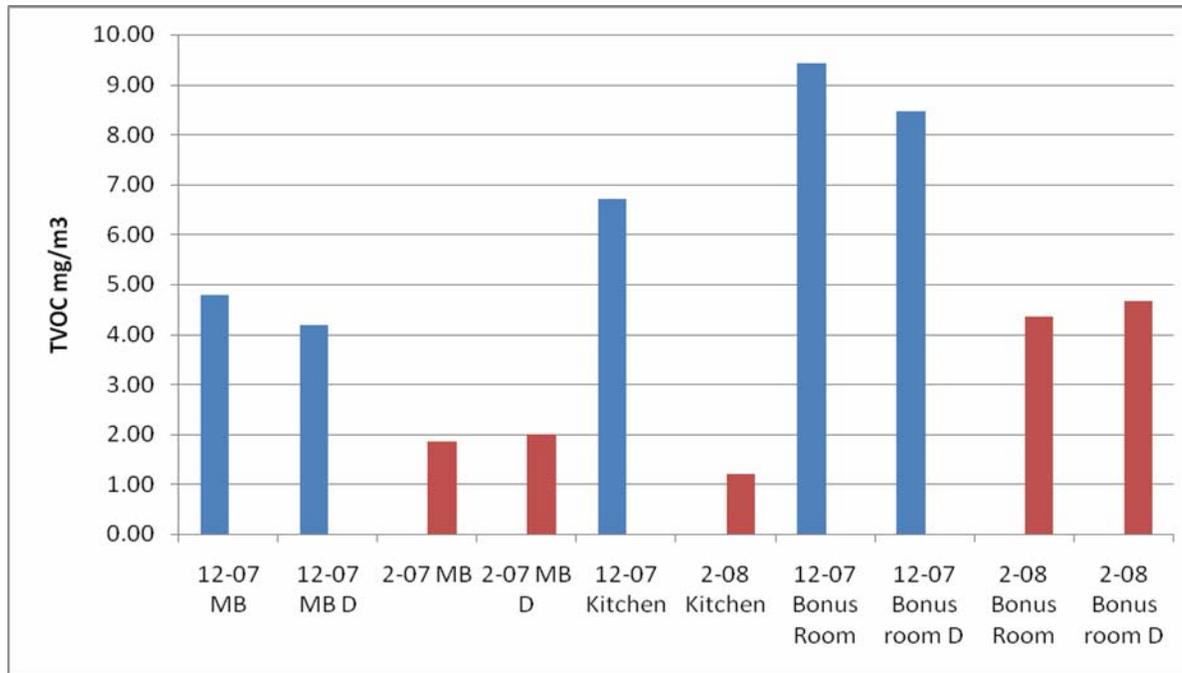
Total Volatile Organic Compound (TVOC) concentrations were initially highest in the Bonus room over the garage, second highest in the kitchen and lowest in the master bedroom. TVOC was reduced between the first and second sampling at all three locations where pre and post occupancy sampling was conducted. In the second set of samples the bonus room levels were about cut in half but remained the highest. The kitchen levels plummeted by a factor of five making it the test area with the lowest TVOC. The master bedroom levels were about cut in half. It is not surprising that the bonus room has the highest concentrations considering the ventilation rate is eight or nine times lower than the master bedroom. It is expected that the building related VOC sources decreased between the first and second sample sets. During the first set of samples sources from wet applied products were present in the house - cleaning and touch-up painting were occurring. Emission rates for many materials rapidly decrease after initial installation (e.g. paints, varnishes, adhesives, carpet systems). However new sources of VOCs were introduced when the owners moved their belongings and furnishings into the house. With the exception of formaldehyde the reduction in building related emissions appears to have had a bigger impact on VOC levels than the introduction of belongings.

Figure 11: TVOC sampling in different location before and after occupancy.

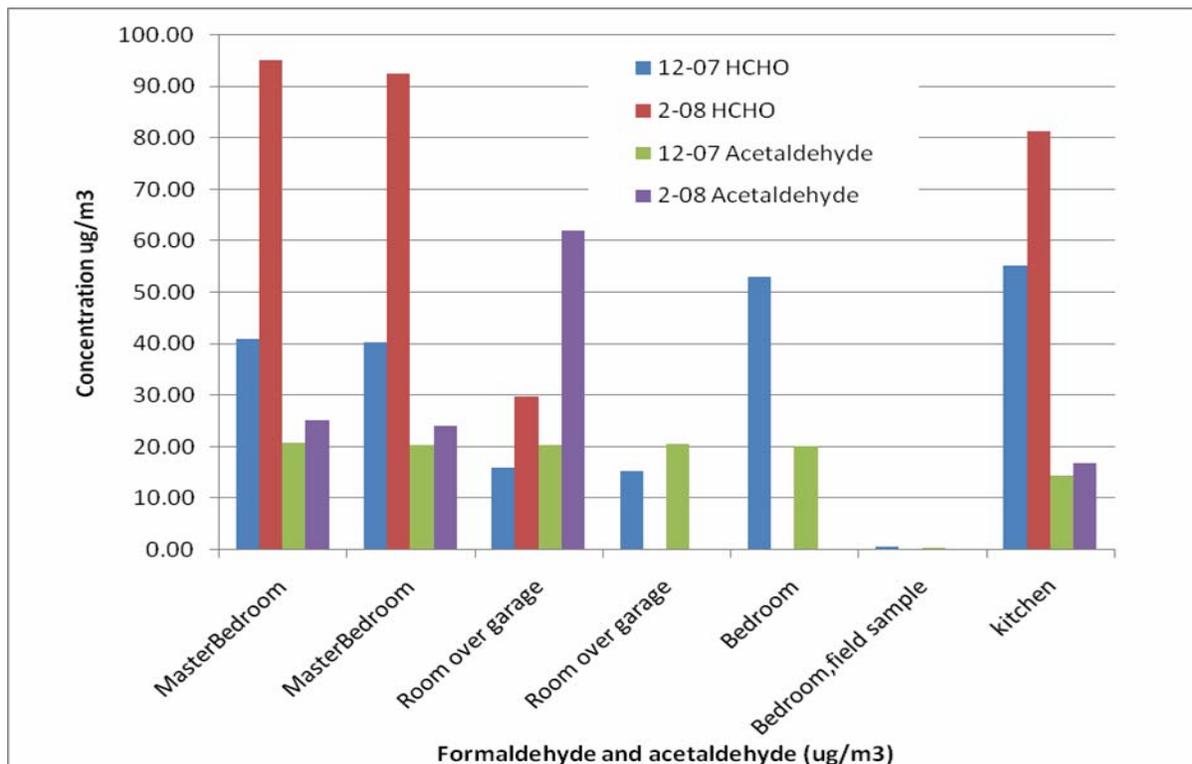
Formaldehyde and acetaldehyde samples were collected on 12/11/07 and on 2/06/08. Initially formaldehyde levels were between 40 and 55 $\mu\text{g}/\text{m}^3$. The kitchen and a secondary bedroom were the highest. Formaldehyde levels in the NRC new house study exceeded 60 $\mu\text{g}/\text{m}^3$ for most of the study period. Hodgson and Levin (2003) report a geometric mean of 39 $\mu\text{g}/\text{m}^3$ and maximum of 76 $\mu\text{g}/\text{m}^3$ in a study of newly constructed residences. However the formaldehyde levels increased between the first and second samples to the point they are outside the levels reported by Hodgson and Levin (2003). The increase is particularly high in the master bedroom where levels are slightly over double what was measured in December. There are two published guidelines for formaldehyde in residences: the Canadian recommendation of 61 $\mu\text{g}/\text{m}^3$ and the California Air Resources Board value of 33 $\mu\text{g}/\text{m}^3$. It is believed that the increase in formaldehyde levels in the master bedroom may be the result of furniture placed in the room between sample sets.

Acetaldehyde levels in the initial samples ranged between 15 and 20 $\mu\text{g}/\text{m}^3$. Hodgson and Levin report a geometric mean of 25 $\mu\text{g}/\text{m}^3$ and a maximum of 77 $\mu\text{g}/\text{m}^3$. Acetaldehyde levels showed minor increases in the second samples in the master bedroom and the kitchen but tripled in the bonus room over the garage. The levels in the kitchen and master bedroom are 25 $\mu\text{g}/\text{m}^3$ the same as the geometric mean reported by Hodgson and Levin. The levels the room over the garage approach the maximum reported by Hodgson and Levin.

Figure 15. Concentration of aldehyde before and after occupancy
