HYDRODEMOLITION— FORGET THE FLAT WORK

BY PATRICK WINKLER

BLANCHETTE BRIDGE REPAIRS

BLANCO DIVERSION DAM Ogee SPILLWAY RESURFACING

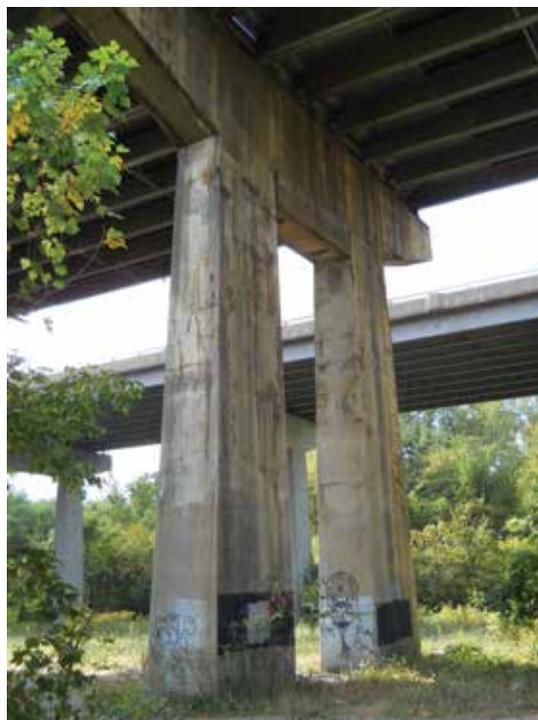
Fig. 2: Substructure pier in need of repair

surfaces to a depth of 3 to 5 in (76 to 127 mm). The delaminated concrete on the pier surfaces was a result of failure of the expansion joints in the roadway above the piers. Open joints allowed de-icing salts to flow down over the piers, initiating corrosion of the embedded reinforcing steel. In several areas, the entire pier surface was delaminated and required repair. Concrete that was sound, yet contained chloride levels above the threshold level to initiate corrosion, was also removed at substructure components.

- Elimination of the three spans nearest to the St. Louis County end and their conversion to roadway on embankment;
- Repair of remaining concrete substructure units including some concrete replacement (Fig. 2);
- Complete replacement of the structural steel in the first nine spans of the bridge on the St. Charles County side;
- Repair of structural steel components for the long girder spans and truss spans; and
- Repainting of existing structural steel.

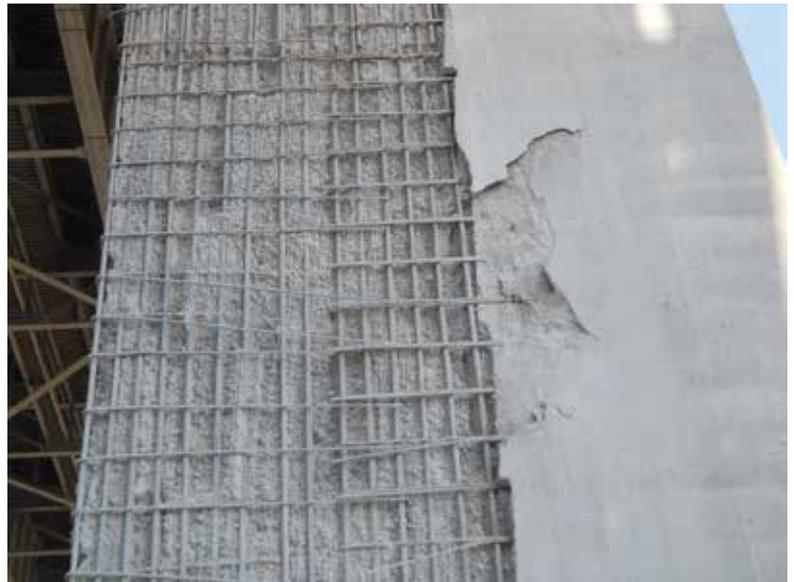
Fig. 4: Removal area adjacent to delaminated concrete

labor intensive and time consuming process. In order to accelerate the project, and minimize the wear and tear on employees, the contractor elected to use specialized hydrodemolition equipment to remove much of the deteriorated concrete. The specialized hydrodemolition unit had an x – y head mounted on the end of the boom of a manlift. The controls to operate the manlift, including travel, rotation, extension, and leveling were removed from the manlift and placed in a control box that was attached to the hydrodemolition unit using an umbilical cord. In addition to the normal functions of the manlift, the control panel also contained the controls to operate the hydrodemolition functions including traverse, index and nozzle rotation as well as pump operation and safety shutdowns. In order to observe the hydrodemolition work, the operator uses a manlift (Fig. 3). The control panel connected to the hydrodemolition unit is placed in the manlift basket with the operator. From the vantage point of the manlift, the operator can move in close to the work area and position the equipment over the area to be cut and then back away from the work as the hydrodemolition is performed. The x – y cutting head is equipped with legs to allow the frame to “touchdown” on the surface, providing a solid base. This is important to allow the cutting head to remain in place during the concrete removal (a significant amount of reactionary force is generated when the hydrodemolition unit starts the actual removals). In addition, this allows the operator to accurately control the height of the nozzle (stand-off) from the work area. The x – y cutting head contains the normal two dimensional movement of a standard hydrodemolition robot allowing the cutting head to move uniformly over the concrete area to be removed (Fig. 4). During the period in

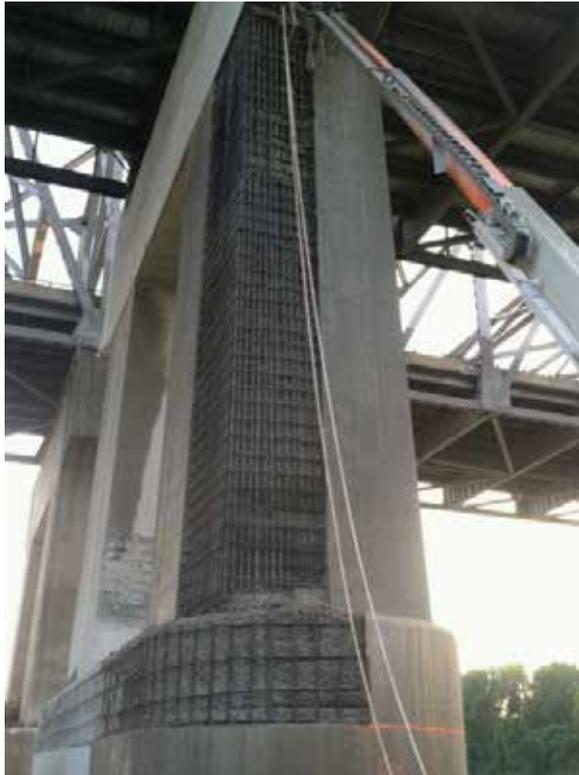
Fig. 5: Full height concrete removal on 25% of the pier

which the westbound lanes were closed and the re-decking was in progress, up to 50% of the column surface area at piers could be removed by hydrodemolition. This work continued following the completion of the decking and reopening of the lanes. Once traffic was back on the bridge, concrete removals were limited to a maximum of 25% of the pier surface (Fig. 5).

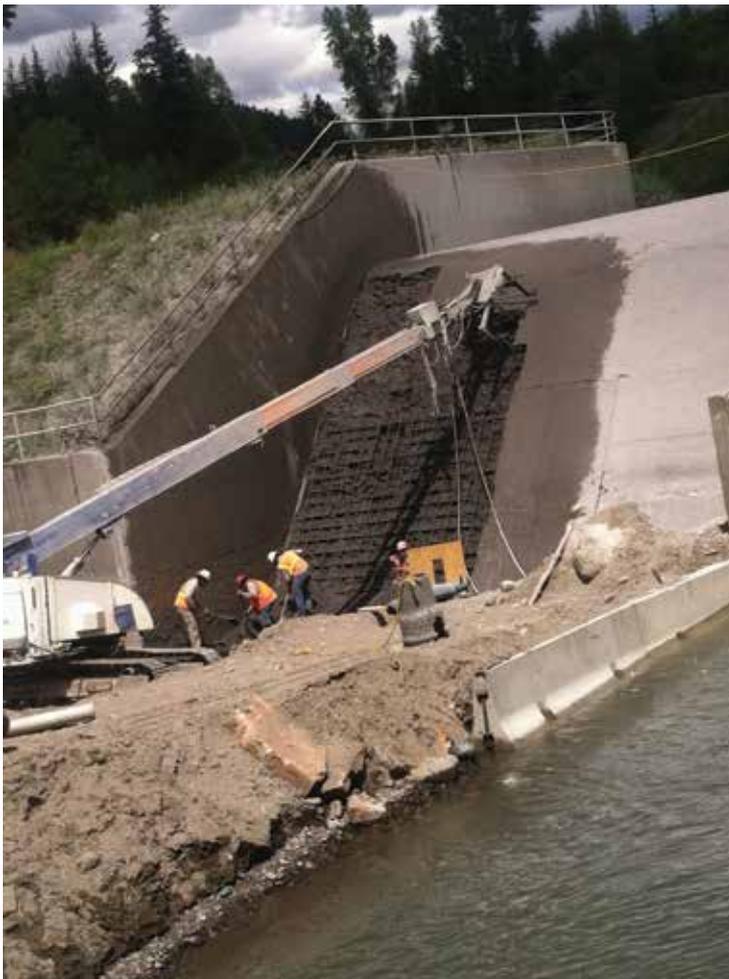
Fig. 7: Hydrodemolition unit removing concrete from the spillway face

A specialized hydrodemolition unit was used to perform the concrete removal work. Once placed in the spillway basin, the hydrodemolition unit could reach the various surfaces requiring hydrodemolition (Fig. 7). The work proceeded from the bottom of the spillway to the top allowing debris to collect in the flip bucket where it was removed. Periodic inspection of the work was performed to ensure proper clearance and to locate damaged reinforcing steel (Fig. 8).

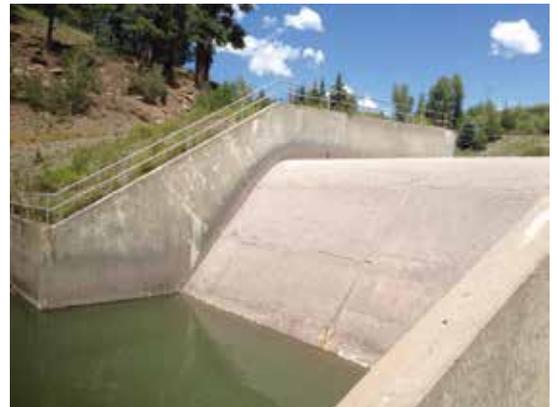
Fig. 6: Blanco Diversion Dam Ogee Spillway removal area adjacent to delaminated concrete

The concrete removal performed by hydrodemolition consisted of approximately 2,750 square feet (255 square meters) of 7 in (178 mm) deep removal to expose the reinforcing steel. The work was performed from manlifts including both the concrete removal and placement of shotcrete. It was important that the work area and spillway basin could be quickly evacuated in the event of heavy rain and potential flooding.

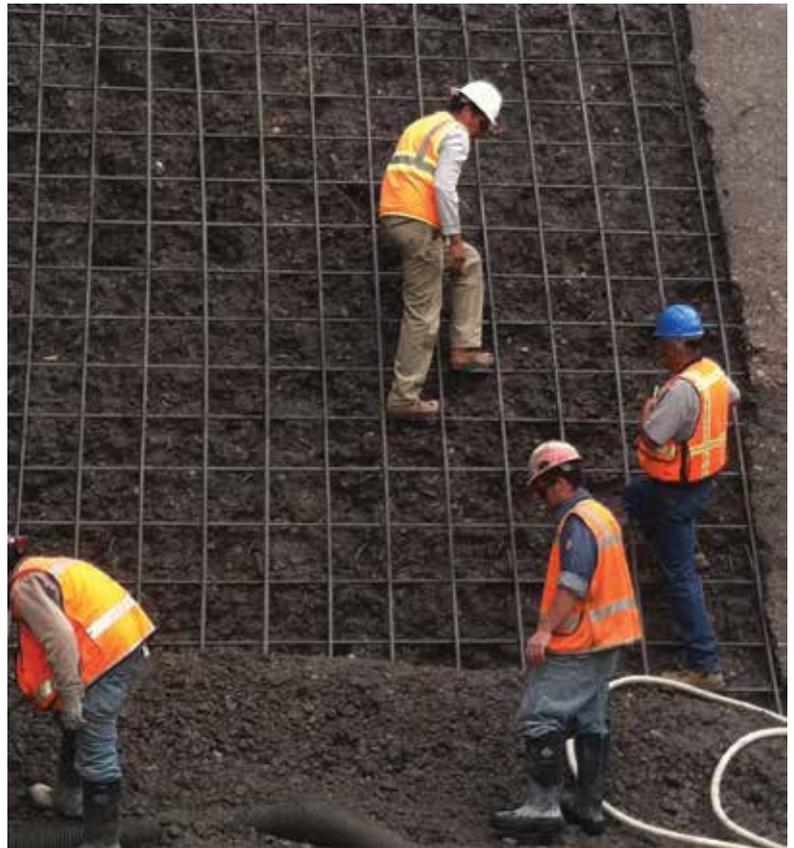
Fig. 8: Inspection of the hydrodemolition removal

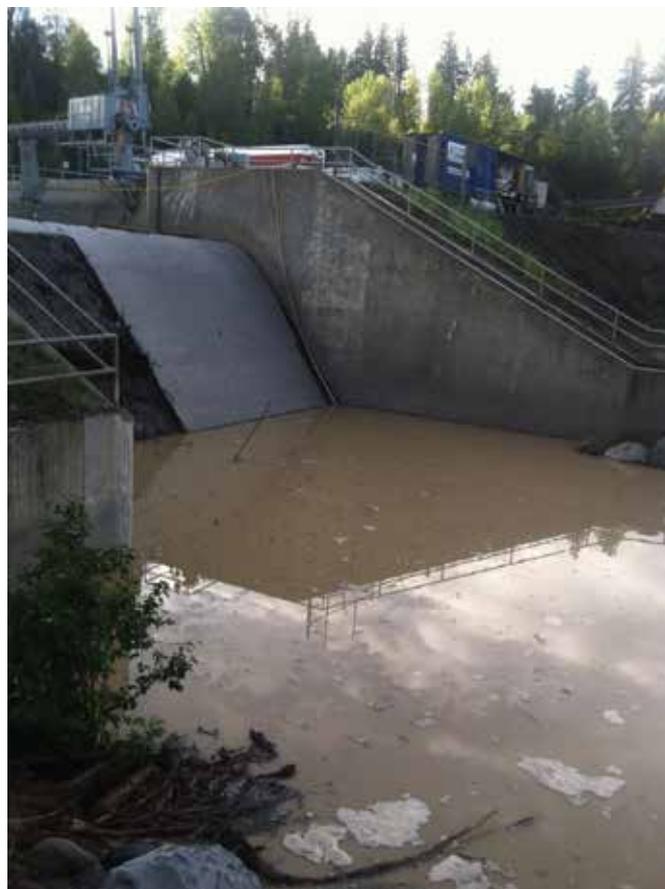
The work was performed in early August 2013. As might be expected, heavy rain developed during the hydrodemolition removals, flooding the spillway basin (Fig. 9). Fortunately, there was sufficient warning and time to remove the equipment from the spillway. Several days were required to allow the water to recede and to again dewater the basin and allow the work to resume.

Fig. 9: Flash flooding of the spillway
