INFLUENCE OF MANUFACTURING METHOD AND SURFACE CONDITION
ON THE FATIGUE STRENGTH OF Ti-6Al-4V MATERIAL

J. Broichhausen, M. Telfah

Rhein.-Westf. Techn. Hochschule, Aachen

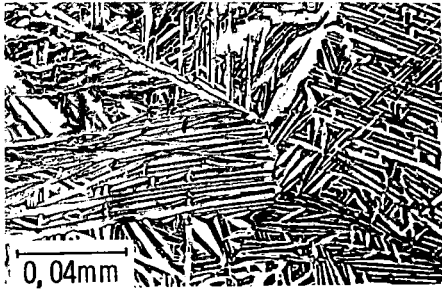
Fig. 4: Structure

The material has a plate-like, equiaxed structure, and most of the alpha plates are arranged in groups (Fig. 4). There are numerous inhomogeneous spherical spots which show up on the microphotos as annular surfaces with an enclosed core (Fig. 5). In these areas the actual hardness is higher than that of the matrix (Fig. 6). The difference in hardness ranges from 35 to 100 Vickers units, indicating an embrittled condition of such areas.

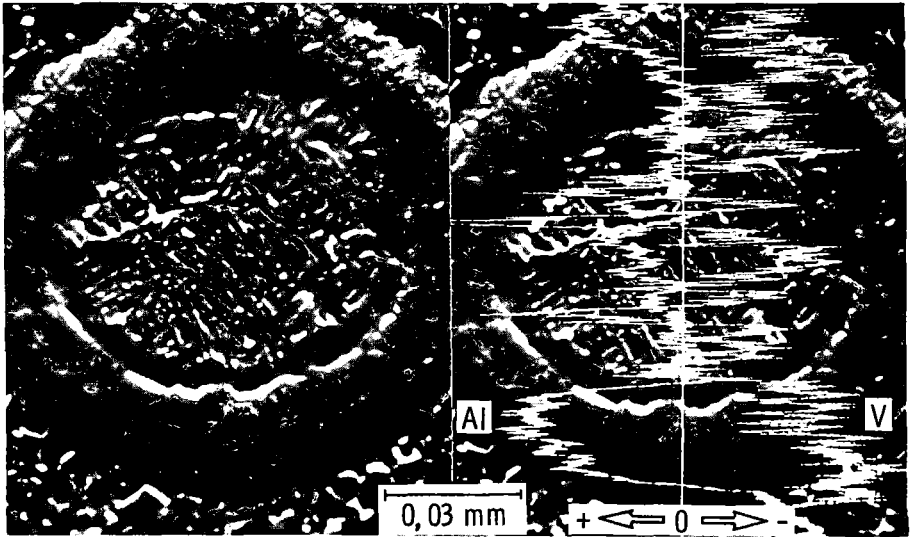
Fig 7: Distribution of Aluminium und Vanadium Concentrations

When the distribution of concentrations in the area shown in Fig. 7a was examined, aluminium enrichment and a lower vanadium concentration were found in the annular surface compared with the matrix (Fig. 7b).

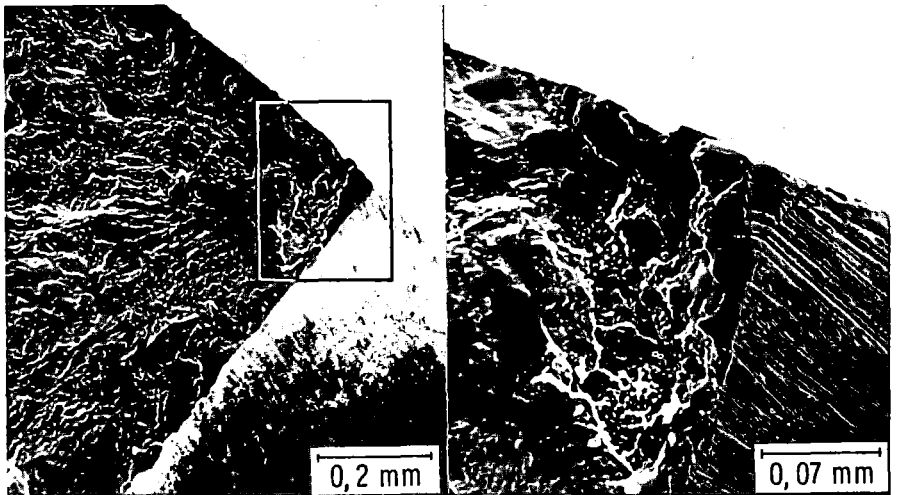
Fig 8: Fatigue Origin

The fracture surfaces indicate that fatigue cracks tended to originate in such areas (Fig. 8). It was found that the concentration of aluminum at the fatigue origin was also higher than that of the surrounding material (Fig. 9).

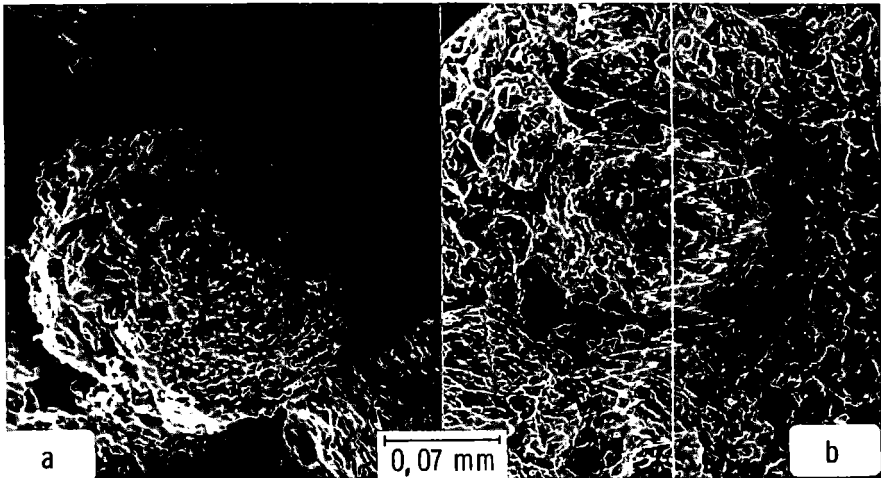
Fig. 10: Spherical Inclusions in the Fatigue Fracture Surface
a) Crack Formation
b) Distribution of Aluminium

In the area of fatigue fracture one also found spherical inclusions which appear to be identical with the above-mentioned inhomogeneous spots because these areas show an aluminium enrichment compared with the matrix (Fig. 10).

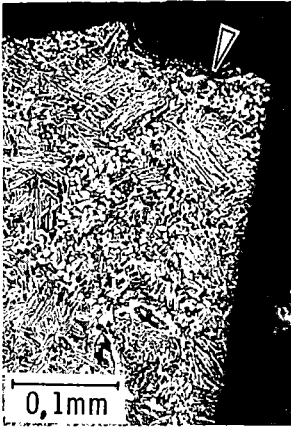
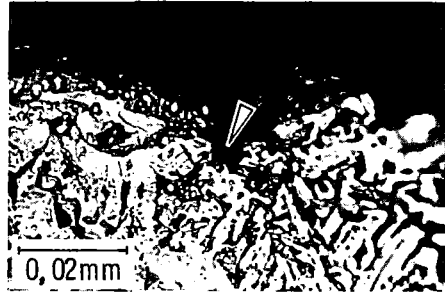
Fig. 11: Fatigue Origin

A transverse section through the fatigue origin confirmed that the inhomogeneous areas are preferred fracture origins and therefore have a considerable influence on actual fatigue strength (Fig. 11). At such locations an intercrystalline weakness of the structure was found to exist.

- Under the circumstances the surface treatments examined did not sufficiently improve the fatigue strength of die-forged test specimens.
- The HIP test specimens were found to contain defects reducing their fatigue strength significantly. These defects can be avoided, however, and defect-free specimens are expected to have a considerably higher fatigue strength.

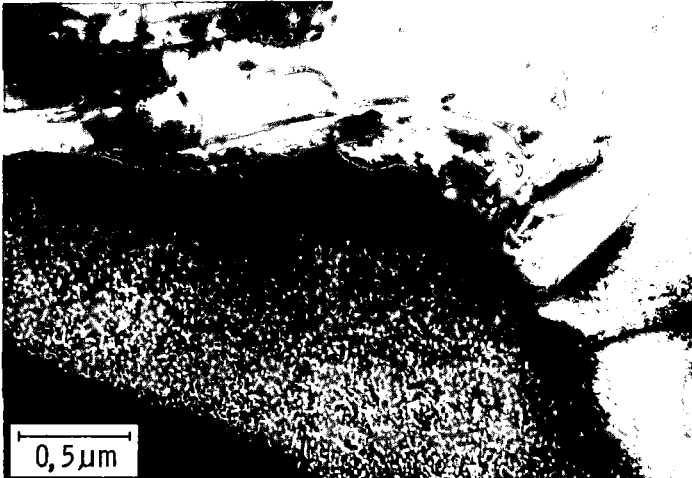
Fig. 12: Seregations in the Structure of the Annular Surface

In the annular surface the alpha phase showed alpha₂ segregations (Fig. 12). These have a hexagonal superstructure and are the result of the existing aluminium enrichment. The higher hardness values found in such areas are due to these segregations.
