INDUSTRIAL TECHNOLOGY

Volume 23, Number 2 - April 2007 through June 2007

Martempering to Improve Wear Properties of Aircraft Brake Steel Rotors

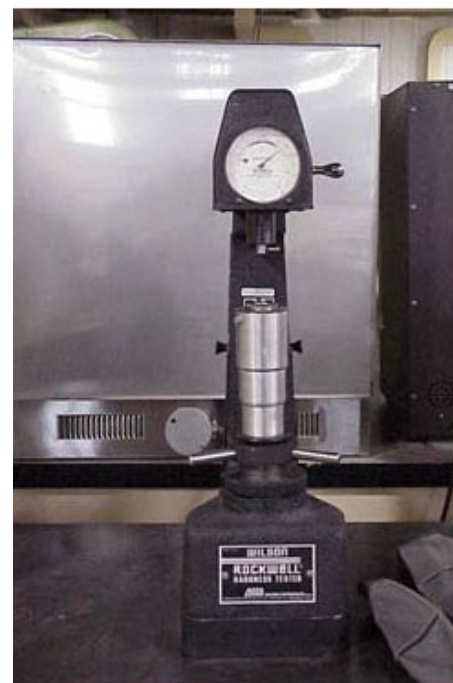
Figure 3. Rockwell Hardness Tester

1. Hardness Testing Machine
Wilson Rockwell Hardness Tester machine was used to measure hardness.

This is shown in figure 3. The Hardness machine can be used with several different scales including Rockwell A-G, H, and K. In this study Rockwell scales B and C were used.

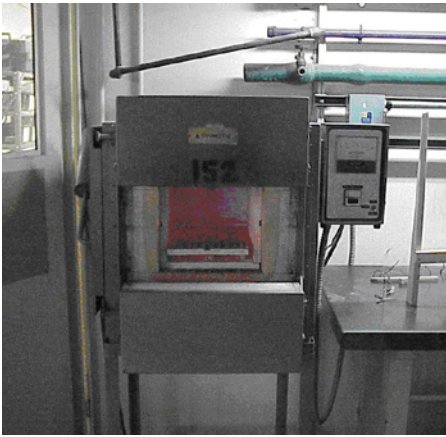
Figure 4. Large Electric Furnace

An electric oven was used to austenize the pucks before they were placed into the quenchant. Figure 4 is a photo of the furnace. The large furnace is made by Therolyne, and model number F-A1730. The furnace has a temperature range of 0° to 2500° F.

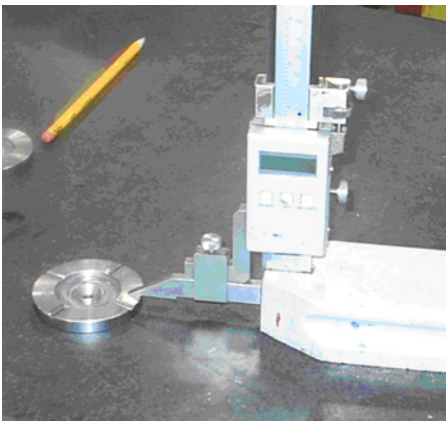
Figure 5. Height Gage / Thickness Measuring

North American Precision Inc. height gage was used to measure the thicknesses at eight different points on the puck. Three measurements at each position were taken to obtain the thickness. Figure 5 shows a close-up view of the gage.

As mentioned above, the part under investigation was the steel puck which forms the rotor part of a brake assembly. It can be seen in figures 5 and 6. The part is approximately 2.5 inches in diameter and 0.33 inch thick. It was received in annealed and machined condition. It was made with the standard 17 – 22 – A Timken steel. The composition of the steel, in percentages, is given in Table 1 (see page 6), as provided by the manufacturer.

The heights were recorded before and after the pucks were heat treated to see if there was any distortion in the axial direction after treatment. The pucks were thoroughly cleaned using sandpaper to remove any scale for the after heat treatment measurements. The set-up is shown in figure 5.

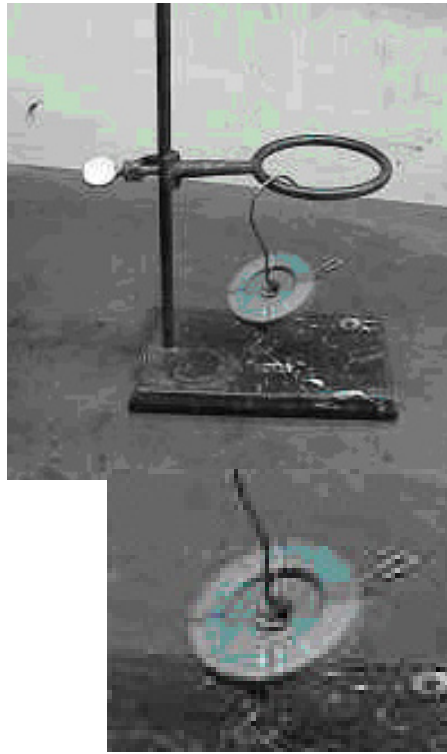
Figure 6. Beaker/Hanger set up and a close-up view

A beaker stand was used as the holding device for the pucks after treatment. The pucks were hung using wire coat hangers bent into a shape to hold them flat while entering the hot quenchant. This presented the maximum surface area during initial contact with the fluid, and so should cause maximum distortion. The coat hanger surface touching the pucks was minimized to avoid uneven cooling. Figure 6 shows this set-up.

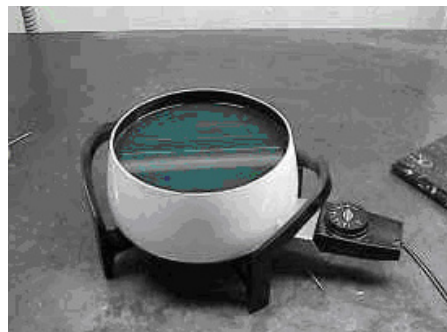
Figure 7. Electric Pot

An electric pot with a temperature setting control was used to quench the pucks. The electric pot is a domestic kitchen pot and has a half gallon holding capacity. The temperature range on the pot is 0° to 400° F. The temperature control was used to set the quenchant temperature and a ‘Suregrip’ thermocouple temperature probe was used to actually monitor the quenchant temperature. This probe has a temperature range of -40° F to 1994° F. Figure 7 is a photo of the electric pot.

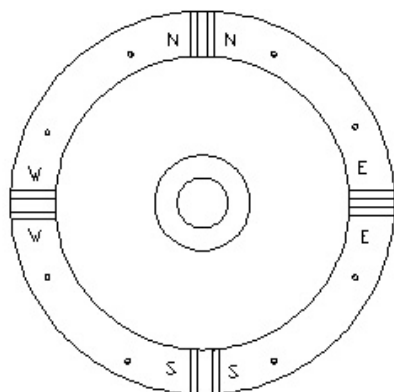
Figure 8: Labeled positions on a steel puck

In order to identify the different pucks, these were stamped with an identifying letter (A to T). In order to be consistent in the various measurements, these were labeled so that the measurement was done at approximately the same place and orientation. The labels consisted of stamped letters N, S, E, W, at two places, in the four directions so their orientation could be quickly found as shown figure 8.

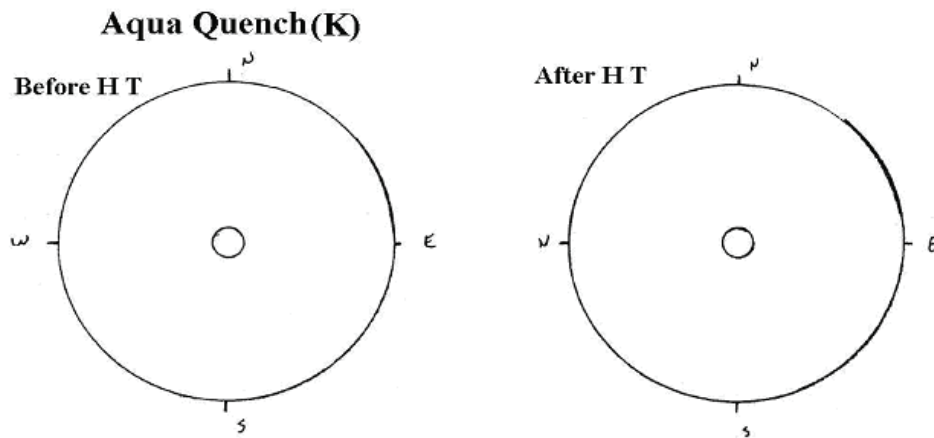
Figure 9. Example of a tracing to determine radial distortion

Although radial distortion is not of much importance in the functioning of the pucks, an attempt was made to measure this. As has been stated, the ideal method for measuring radial distortion would have been to use a profilometer or a CMM. In absence of such apparatus the above described tracing method was used. In all the eight parts used, no radial distortion was detected. An estimate of the accuracy of this method can be obtained as follows:

The visual error in the procedure of comparing the two tracings can be said to be half of the pencil line width, so it is in the order of 0.5 mm. Since the diameter of the puck was about 65 mm, the measurement error translates to 1.54 %. (1mm/65mm * 100 = 1.54). An example of the tracing is shown in figure 9.
