FRETTING AND FRETTING FATIGUE OF TITANIUM ALLOYS  
UNDER CONDITIONS OF HIGH NORMAL LOAD

Suehiro Goto\* and Robert Barry Waterhouse

Department of Metallurgy and Materials Science,  
University of Nottingham, Nottingham NG7 2RD, U.K.

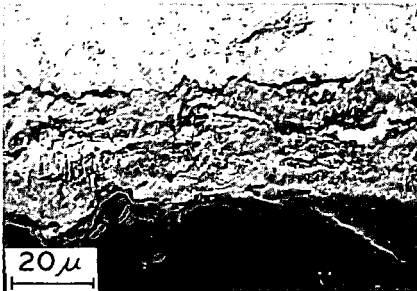
Fig.6 Ti-6Al-5Zr-0.25Mo-0.25Si after fretting and ultrasonically cleaning. F=500 N, P=7500 N, 1000 cycles.

Fig.7 As Fig.6, 5000 cycles.

Fig.8 As Fig.6 30000 cycles.

extruded out of the contact. Figs. 4 and 5 show the appearance of the scrub and debris on removing a specimen of Ti-6Al-4V from the machine which had experienced  $10^6$  cycles of fretting. The size of the debris is  $2\ \mu\text{m}$  and less. All the specimens were ultrasonically cleaned to remove the loose debris and examined in the Cambridge 600 Stereoscan scanning electron microscope. On all three materials the annular ring of fretting damage increased from isolated pits after 1000 cycles to become a continuous band of damage as the number of cycles rose to 30000 cycles. Figs.6,7 and 8 show this progression on IMI 685. After 5000 cycles there is evidence of compacted debris towards the outer edge of the contact and delamination at the inner edge, Fig.7. The damage develops more rapidly on IMI 318. After only 1000 cycles the individual pits have joined up to give the appearance of a continuous peripheral crack, Fig.9 and after 30000 cycles several fatigue cracks are observed propagating out of the fretting region, Fig.10. Fig.11 shows a fatigue crack propagating from the damaged area on IMI 685 after 300000 cycles.

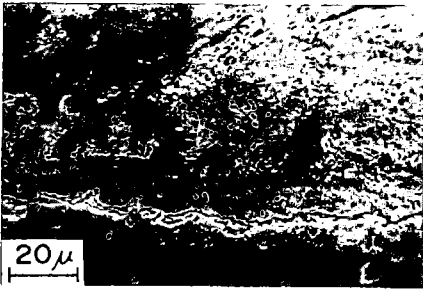
Fig.9 Ti-6Al-4V after fretting showing peripheral crack. F=500 N, P=7500 N, 1000 cycles.

Fig.10 As Fig.9, 30000 cycles. Fatigue cracks propagating from the fretted region.
