Counterweight Repair of Historic St. Charles Air Line Bridge

Chicago, IL

Submitted by Vector Construction

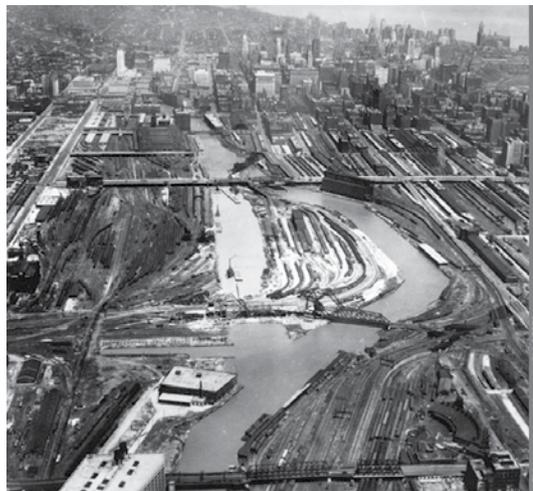
Fig. 3: The south branch of the Chicago River was straightened and the bridge relocated in 1930

The south branch was straightened between 1927 and 1929 (Fig. 3). In 1930, the bridge was moved one-quarter of a mile (0.4 km) to the west and shortened to approximately 220 ft (67 m) in length to span the narrower relocated riverbed. At that time, the bridge also received newly constructed concrete counterweights to rebalance the bridge.

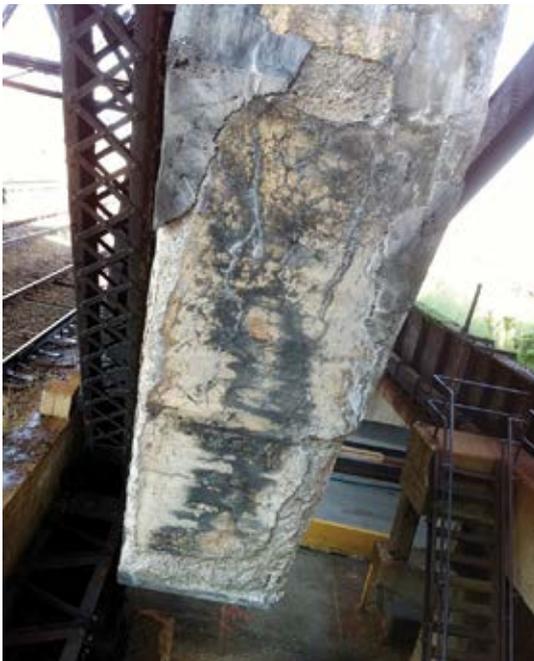
Fig. 6: Condition of the winged concrete counterweight

The concrete counterweights exhibited surface scaling and freezing-and-thawing damage (Fig. 6 and 7). Deteriorating and falling concrete was a safety hazard to people and property below and could cause the bridge to be out of balance, thus not raising or lowering in a smooth fashion.

However, the deterioration continued to advance over time, leading CN to implement a new plan to repair and protect the entire counterweight surface. This time, a majority of the counterweight surface would be repaired, and the entire surface strengthened and protected with a surface-applied fiber-reinforced polymer (FRP) system.

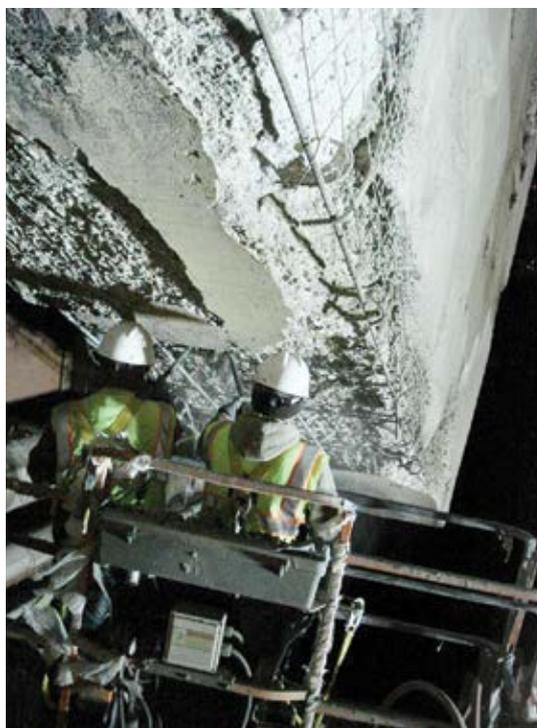
Fig. 8: Concrete removal was limited to 3 yd³ (2.3 m³) to maintain balance during repairs

The repairs were completed using a regular nightly work schedule, during a 10-hour window when there was less train traffic, including no Amtrak trains, and no river traffic (refer to Table 1). To maintain the bridge balance, a maximum of 3 yd³ (2.3 m³) of concrete could be removed at one time (Fig. 8).

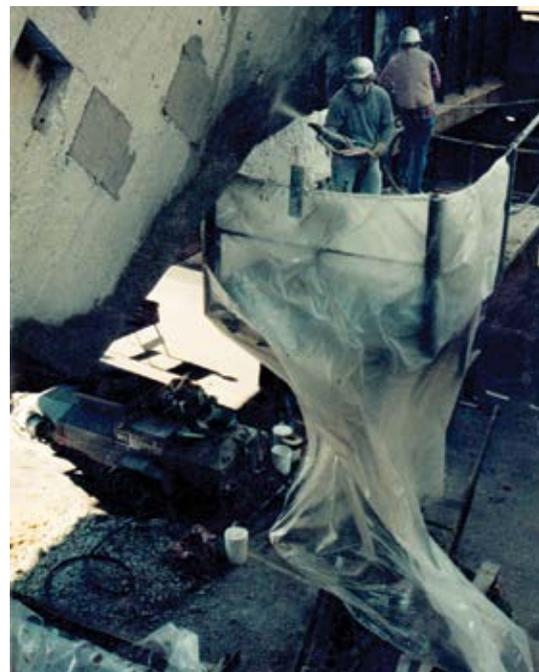
Fig. 10: Wet-mix shotcrete was selected for the repair material

Wet-mix shotcrete was selected as the repair method (Fig. 10) using custom-designed equipment that allowed for vertical pumping and placement at heights up to 100 ft (30 m). The pressure pump contained internal agitators to keep the wet-mix shotcrete fluid and allow for instant on/off control by the nozzleman.

A prepackaged wet shotcrete mixture was selected for the repair material, as it offered the convenience of reduced material handling as well as excellent product quality. The selected shotcrete material was a superplasticized 5000 psi (34.5 MPa) mixture, 20% addition of 3/8 in. (9.5 mm) pea gravel, and accelerator added at the nozzle. After the shotcrete was placed, it was cut back and finished level with the existing counterweight surface (Fig. 11).
