## INTRODUCTION

### 1. General Description

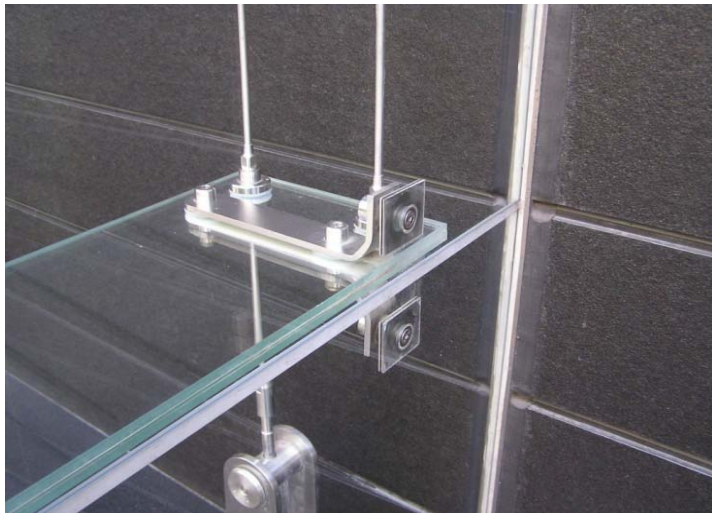
Figure 1. Example of the vocabulary challenge. The structural glass wall, with horizontal structural glass mullions suspended on stainless steel cables. The glass fins play structural role by resisting lateral load, as opposed to the traditional load-collecting role of glass. No structural sealant used here.

As many specification writers are well aware, even classification of this, relatively narrow group of curtain walls may present a challenge. An example of possible ambiguity is the adjective “structural” used in the expression „structural curtain wall.” It’s traditionally interpreted as a description of the characteristic of the adhesive used for bonding glass to its framing substrate. More recently it became used to describe the desired characteristics of glass used to build the frame itself (as opposed to the infill material) sometimes without use of any adhesive material. (See Figure 1). Some countries developed early code-referenced standards and glossaries, e.g. UK, Germany, China, and Australia. (e.g. EN 13119: Curtain walling – Terminology. 2007)

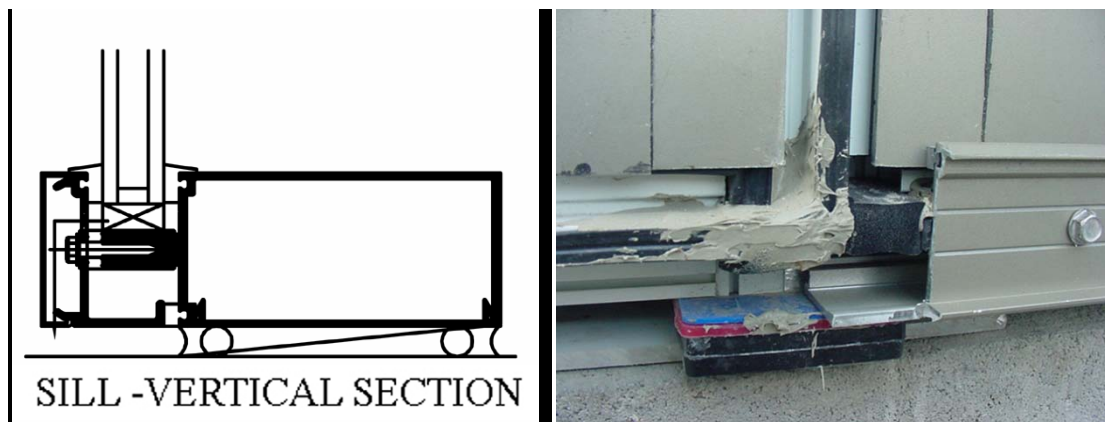
Figure 5. A typical vertical section detail of exterior wall's sill and a photo of the same condition in the field. The front sealant joint is discontinued at every anchor and corner. The back sealant attaches to horizontal mullion which is discontinued at corners and forms gaps at every end. Both sealant beads have insufficient substrate width. The sealant joints, traced 360° around the fenestration perimeter, would typically not withstand the differential movement. The horizontal aluminum leg bridges the mullion thermally. Field-applied systemic sealant separates wet and dry zones of the curtain wall.

A capable joinery employed to accommodate the movements is the key to wall's integrity. A wall is only as good as its weakest component, which almost invariably happens to be joinery. Seals of the systemic joinery and intra-system transitions should perform all the required façade protective functions and allow for free movement. (See Figure 6). The recognition of this principle led to development of many well-performing detail solutions seen in the off-the-shelf foreign systems and sophisticated domestic custom curtain walling, (ranging from use of a dedicated inserts and collars of elastomeric membrane coupled with generous overlaps). These solutions are contrasted with the poorly performing details characterized by a single sealant joint performing all façade control functions, subjected to differential movements in excess of its elasticity, and interrupted at every anchor and corner, with another sealant joint placed in the back, attaching to a non-continuous substrates (horizontal mullion) and interrupted at every anchor and corner. This solution was publicly identified as incorrect in America almost 30 years ago (R.L. Quirouette, 1982). Unfortunately, this solution is still seen prevalent in domestic manufacturers' catalogs and stems from misunderstanding of functions performed by curtain wall components and the exact location of the boundary between wet and dry environments. (See Figure 5).

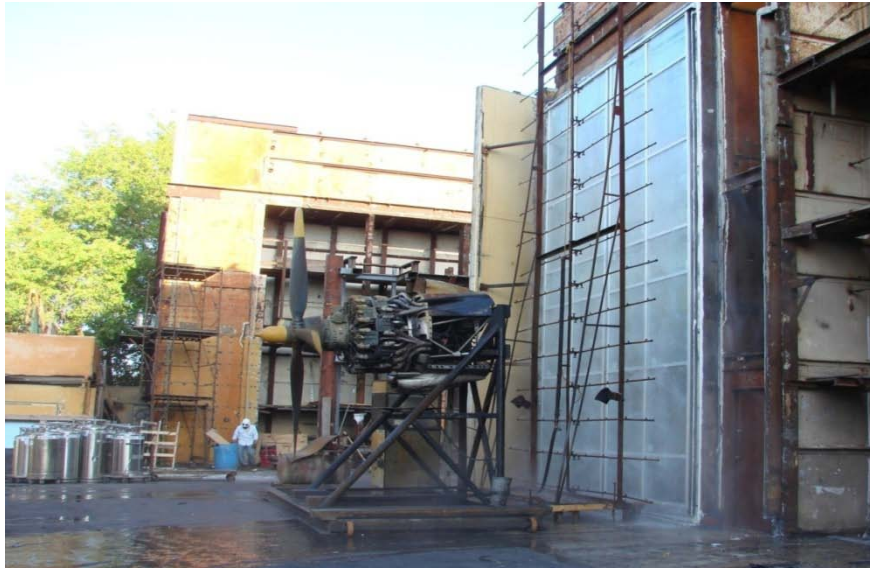
Figure 7. Dynamic water testing of a curtain wall in a laboratory. Only 5% of walls generally pass their first test.

Generally, how resistant are curtain walls to failures? The data is not easily available. Owners and managers, who would be the best source of the data, are incidentally the party least eager to speak up for public relations purposes. The data is available from construction testing instead. Mockup testing is crucial in assessing unproven systems and for the purposes of contributing to subsequently finalized designs. Generally, only the most prominent projects have sufficient funding to individually test their walls. The mockups built for the laboratory tests generally represent the highest and best contractors' efforts on the largest and best projects. Therefore, the results are hardly random. The owner of one of the largest wall mockup testing laboratories in the world, where many of the most prominent building walls were tested, ranging from Sears Towers in Chicago to Petronas Towers in Kuala Lumpur, estimated in 2007 that 95% of walls tested in his laboratory failed their first tests. The typical testing includes a dynamic water testing and structural test at 100% and 150% of the design wind pressure. (See Figure 7).

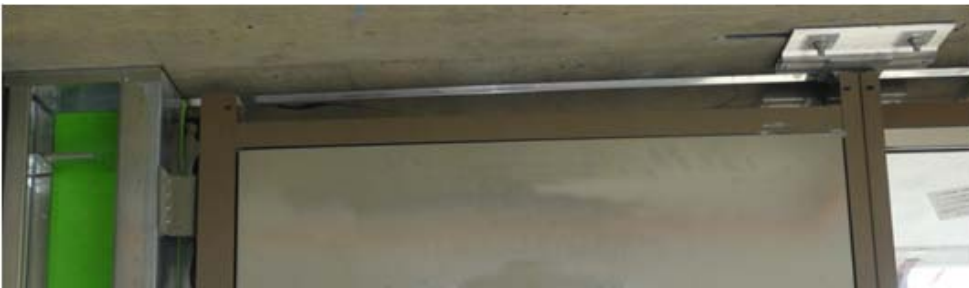
Figure 11. Interior photograph of the head of exterior wall. Indirect support of a glazed curtain wall jamb mullion through an adjacent light gage metal framing. (Note the stub of the single deflection track on the left side.)

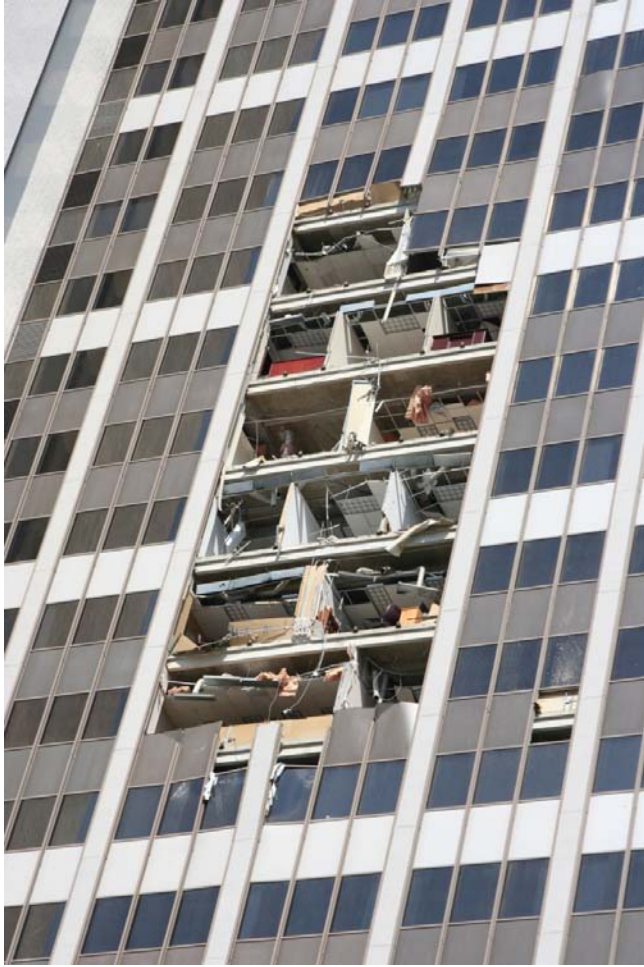
Figure 12. Exterior photograph of exterior wall. A spectacular, catastrophic collapse resulting from uncoordinated support of a curtain wall.. Jamb aluminum mullions were exclusively supported onto adjacent CMU piers, which had insufficient load resistance to collect design reactions from the curtain wall. Photo credit – Mr. Alessandro Abate.

If only 5% of the best walls passed their first mockup test, how well would the average wall perform? Mother Nature conducted an informative, accidentally random test up to the wind requirements set by previous building codes but no curtain wall specific statistical data is available. The Hurricane Wilma became a true test fir hurricane resistance of building inventory in South Florida. According to the weather data collected by NOAA, generally no wind speed was recorded that significantly exceeded the wind resistance requirements set by previous Florida building codes (110 and 120mph). The highest recorded gusts were in the 100-120 mph range. Wilma's eye passed over five counties in South Florida: occupied by population of 5.3 million, living on 8303 square miles according to the 2000 census (U.S. Census Bureau). Property damages reported in Florida, (not limited to the wind peril and not limited to walls), exceeded \$10 billion of 2005 USD (Pasch et all, 2006) – which makes approximately \$2000 per capita. There is no specific curtain wall damage actuarial data available. The analysis is complicated by several factors, e.g. two different methodologies in calculating wind gusts (fastest mile and 3 second gust) and by the following hurricane Katrina, much gentler than Hurricane Wilma in South Florida, but causing damage difficult to distinguish from Wilma. The general conclusion is that significant percentage of construction doesn't meet basic building code requirements. Based on this author's observations, curtain walls frequently failed by water infiltration and detachment and fall of wall components (characterized by e.g. missing aluminum trim - snap caps) in addition to sustaining widespread impact damage by windborne debris. Some assemblies failed catastrophically, revealing a defective assembly. (See Figure 12).

**Results:** The ultimate result of the “triple witching” described above is failures observed in the field. One spectacular failure stems from the attempts of detailing a curtain wall like a window: with perimeter attachments, as opposed to a simple span frame. A curtain wall is seen with jamb mullions attached to an adjacent structure, as opposed to the remaining mullions which are attached directly the structure. The adjacent structure would need to have sufficient load resistance to take the reactions from the jambs. (See Figure 10 exemplifying this challenge). This may be correct if the adjacent system is capable of safely transferring the curtain wall reactions onto the main frame and the differential movements are verified. However, more often than not, the adjacent system is not fully coordinated. (See Figure 11). An example of a resulting failure is shown in Figure 12. The wall was designed to 110mph fastest mile wind load and failed during Hurricane Wilma. Initial breakage of glass caused unanticipated service condition: pressurization of the building interior. Aluminum jamb mullions were exclusively supported onto adjacent CMU piers, which were not designed to collect reactions from the curtain wall.
