INFLUENCE OF MANUFACTURING METHOD AND SURFACE CONDITION
ON THE FATIGUE STRENGTH OF Ti-6Al-4V MATERIAL

J. Broichhausen, M. Telfah

Rhein.-Westf. Techn. Hochschule, Aachen

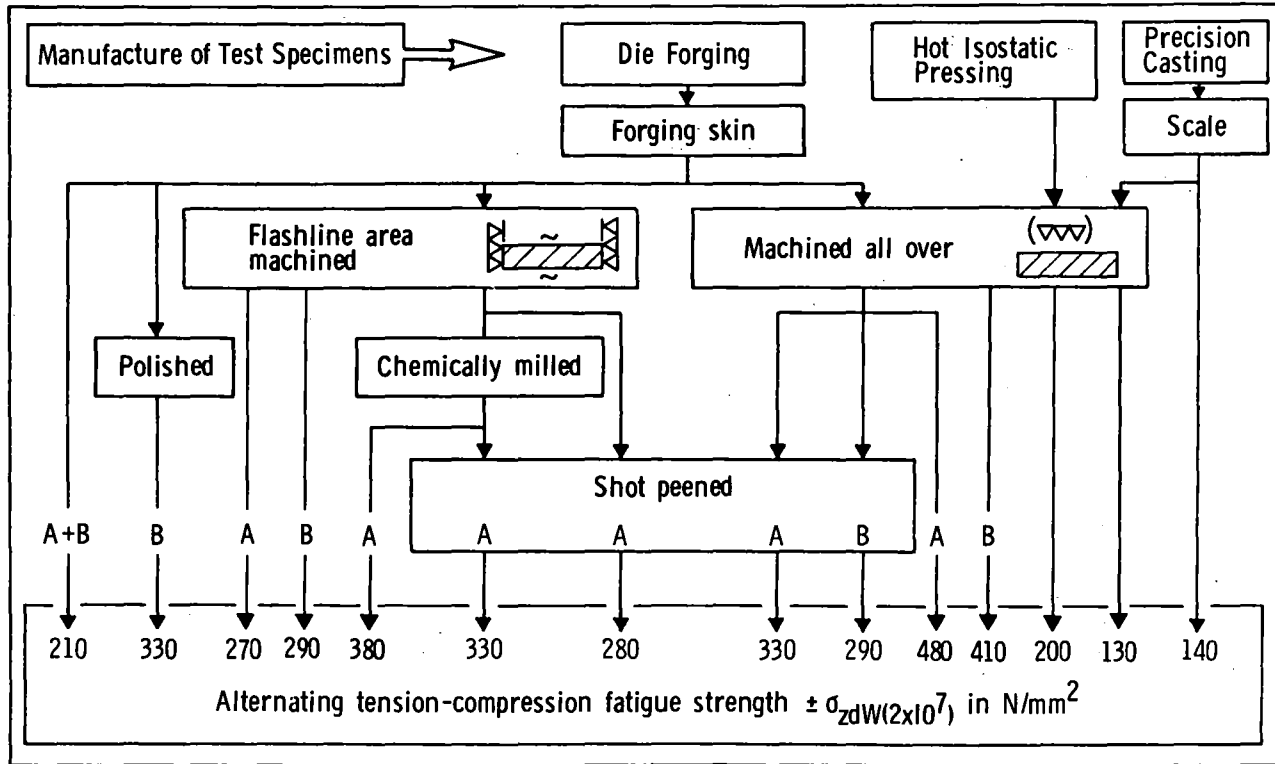
Fig. 1: Manufacture of Test Specimens; Surface Conditions and Treatments; Fatigue Strength

The die-forged test specimens notches in the flashline area due to the trimming operation. These notches, which can be avoided, have a detrimental effect on actual fatigue strength, and with the exception of one test series the narrow sides of the specimens were therefore machined prior to any subsequent surface treatment. These specimens were subjected to the standard processes indicated in Fig. 1.

The alternating tension-compression fatigue strength of the test material was determined by single-stage testing at an ultimate number of cycles of 2×10^7 . Fig. 1 summarises the various investigations and also the results obtained.

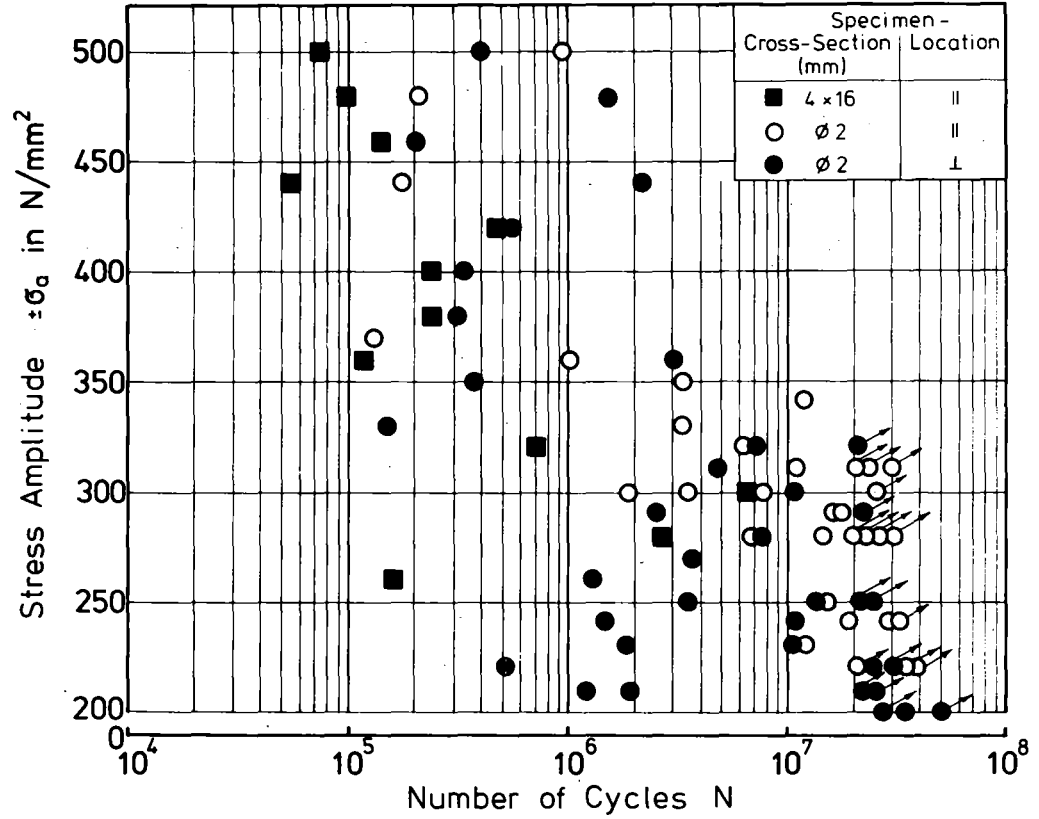
Fig. 3: Fatigue Strength of P/M HIP Test Specimens

As only 12 standard test specimens could be taken from the available HIP material, additional sub-standard specimens of 2 mm gauge diameter were machined from the grip heads of used standard specimens for further investigations regarding the level and directionality of alternating tension-compression strengths. The results of these tests are presented in Fig. 3.

This diagram shows that the results obtained on both standard and sub-standard test specimens scatter widely, and that actual fatigue strength is inadequate
