HYDRODEMOLITION— FORGET THE FLAT WORK

BY PATRICK WINKLER

BLANCHETTE BRIDGE REPAIRS

BLANCO DIVERSION DAM Ogee SPILLWAY RESURFACING

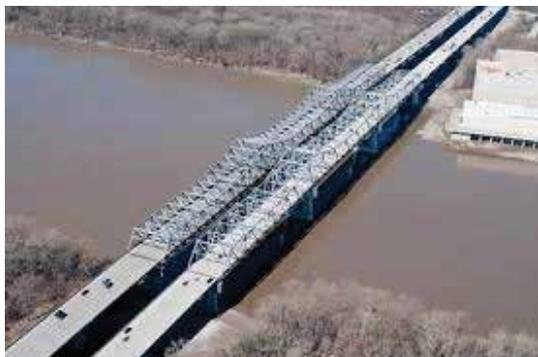
Fig. 1: I-70 Bridge (Blanchette Bridge) over the Missouri River

Bridge (Blanchette Bridge) shown in Figure 1. The bridge over the Missouri River, which connects St. Louis and St. Charles counties, was built in the late 1950s and had experienced significant deterioration. Without major repairs, the bridge would continue to deteriorate, requiring emergency repairs at more frequent intervals with longer traffic closures and delays. These repairs would become increasingly more expensive.

The rehabilitation of the Westbound I-70 Bridge included:

- Removal and replacement of the existing truss spans with new trusses;
- Replacement of the complete driving surface, edge barrier walls and expansion joints;

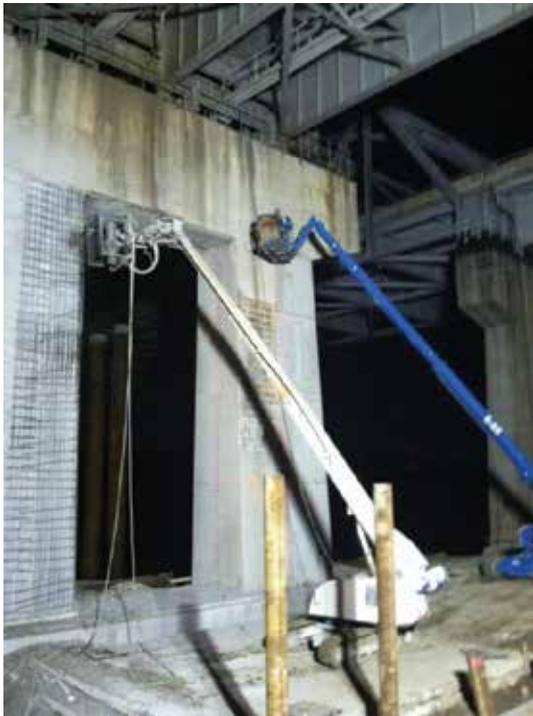
The repair of the concrete substructure included the removal and replacement of approximately 44,000 square feet (4088 square meters) of pier

Fig. 3: Operator in manlift observing the hydrodemolition

surfaces to a depth of 3 to 5 in (76 to 127 mm). The delaminated concrete on the pier surfaces was a result of failure of the expansion joints in the roadway above the piers. Open joints allowed de-icing salts to flow down over the piers, initiating corrosion of the embedded reinforcing steel. In several areas, the entire pier surface was delaminated and required repair. Concrete that was sound, yet contained chloride levels above the threshold level to initiate corrosion, was also removed at substructure components.

Originally, the contractor planned to remove the deteriorated concrete using chipping hammers, a

labor intensive and time consuming process. In order to accelerate the project, and minimize the wear and tear on employees, the contractor elected to use specialized hydrodemolition equipment to remove much of the deteriorated concrete. The specialized hydrodemolition unit had an x – y head mounted on the end of the boom of a manlift. The controls to operate the manlift, including travel, rotation, extension, and leveling were removed from the manlift and placed in a control box that was attached to the hydrodemolition unit using an umbilical cord. In addition to the normal functions of the manlift, the control panel also contained the controls to operate the hydrodemolition functions including traverse, index and nozzle rotation as well as pump operation and safety shutdowns. In order to observe the hydrodemolition work, the operator uses a manlift (Fig. 3). The control panel connected to the hydrodemolition unit is placed in the manlift basket with the operator. From the vantage point of the manlift, the operator can move in close to the work area and position the equipment over the area to be cut and then back away from the work as the hydrodemolition is performed. The x – y cutting head is equipped with legs to allow the frame to “touchdown” on the surface, providing a solid base. This is important to allow the cutting head to remain in place during the concrete removal (a significant amount of reactionary force is generated when the hydrodemolition unit starts the actual removals). In addition, this allows the operator to accurately control the height of the nozzle (stand-off) from the work area. The x – y cutting head contains the normal two dimensional movement of a standard hydrodemolition robot allowing the cutting head to move uniformly over the concrete area to be removed (Fig. 4). During the period in
